10. EAGLE TURIN (at times referred to as "vessel") is a Singapore flagged crude oil tank vessel, assigned IMO No. 9360465, and having the following principle dimensions: 809.7 feet length; 137.7 feet beam; and 69.9 feet depth.

18. At the time of incident, August 5, 2020, the EAGLE TURIN was at the pilot boarding location in preparations to embark Captain Murray, for docking at an oil facility in the Port of New York and New Jersey, United States of America.

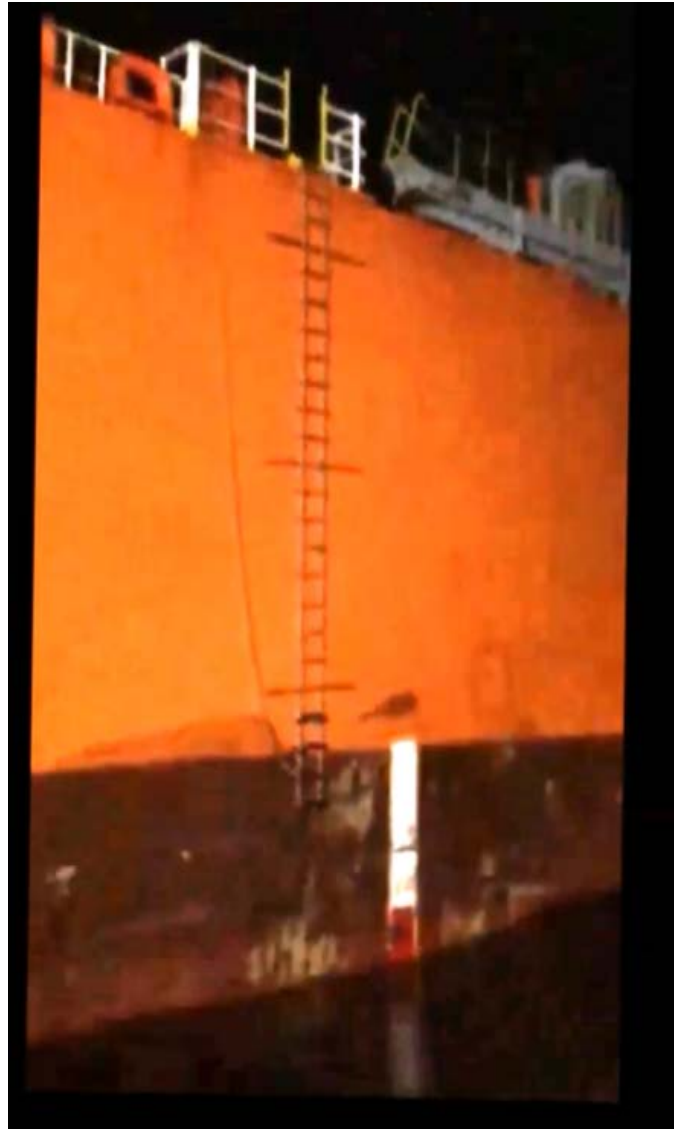
Image No. 1. EAGLE TURIN pilot ladder

25. Image No. 1, above, was taken from the launch boat YANKEE, minutes after the fatal incident (fall), while the launch boat AMERICA was heading with Captain Murray onboard to Staten Island, to obtain emergency medical treatment for Captain Murray.
26. U.S. Coast Guard summaries of crewmember interviews report that immediately before his fatal fall, Captain Murray was at or near the top of the pilot ladder depicted in Image No. 1, above.

37. EAGLE TURIN has a Pilot Line painted on her hull. The Pilot Line is the white vertical line with a red rectangle, towards the right of the pilot ladder, as which can be seen near the bottom of Image No. 1 above.

42. The significance of the Pilot Line is that if any part of the color “red” is showing, the ‘9 meter’ SOLAS limit has been exceeded, thereby preventing use of a pilot ladder and requiring a combination arrangement.
43. At the time the pilot launch AMERICA came alongside EAGLE TURIN, to permit Captain Murray to embark, the Pilot Line was displaying “red”, as can be plainly seen near the bottom of Image No. 1 above.
44. EAGLE TURIN did not provide a combination arrangement for Captain Murray’s embarkation, negligently causing and/or contributing to Captain Murry’s falling from the vessel as he attempted to board the vessel via the provided pilot ladder.

92. Had the EAGLE TURIN provided a combination arrangement as required by SOLAS Instruments, not only would the accident have been avoided, but even if Captain Murray had fallen for any reason while climbing to the accommodation ladder platform, the distance of his fall would have been greatly reduced and he would have survived the fall sustaining relatively minor injuries.

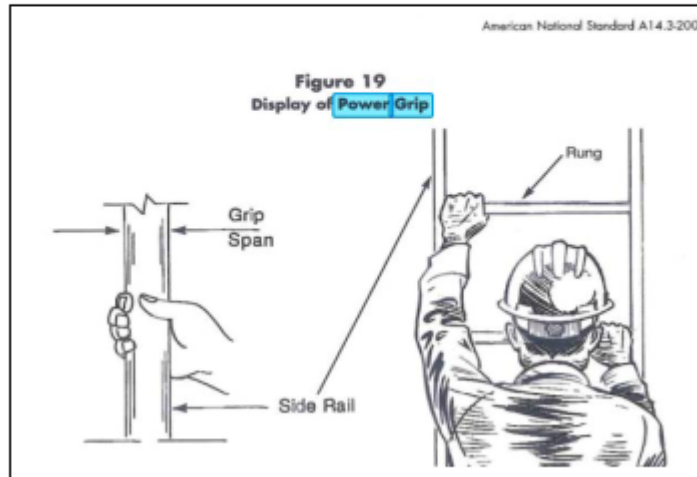
Image No. 2. Power Grip

53. The handrail obstructions prevent obtainment of a proper grip, which is known as a "power grip". (See Image No. 2 below.)

Power grip. The individual's ability to wrap the fingers around an object and oppose the base of the thumb. In this grip, the force exerted by the fingers is approximately equal and opposite to that exerted by the thumb (See Fig. 19).
